Swift BAT Loop Heat Pipe #0 Temperature Droop Problem and Solution after Its Primary Heater Controller Failure

Michael K. Choi*

NASA Goddard Space Flight Center, Greenbelt, MD 20771

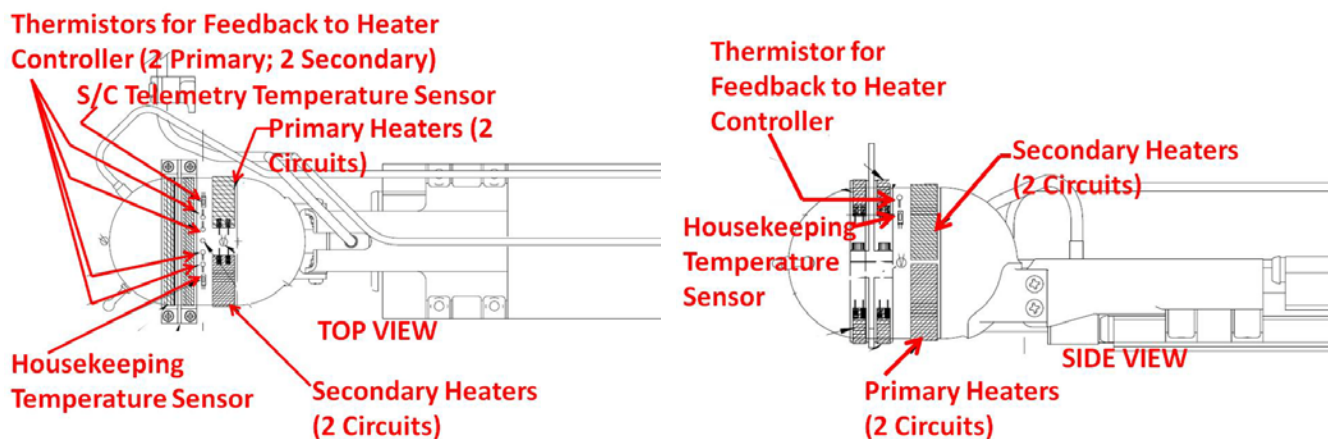
Figure 12. CC Temperature Sensor and Heater Locations.

On April 3, 2010, the LHP #0 primary heater controller was disabled and the set point of LHP #0 secondary heat controller was increased from 6°C to 8°C. From the CC temperature in Figure 11, the secondary heater controller had a significantly larger tolerance than that of the primary heater controller in Figure 8. The AD590 temperature sensor for housekeeping telemetry and the thermistor for feedback to the heater controller are both adjacent to the heater (Figure 12). Secondly the temperature of the liquid return at the CC inlet had a wider range than that before the primary heater controller failed. Thirdly the Block temperature was colder than before the heater controller failure. On April 6, a temperature droop occurred. It recovered in one orbit (Figure 13). Also telemetry BPWHLHPA5TEMP violated the alarm low limit. This temperature sensor measures the temperature of propylene liquid at the LHP CC inlet, where liquid returns to the CC from the VCHP heat exchanger (Figures 14 and 15).
